Shannon & Wilson's State-of-the-Art Monitoring System Prevents Flooding on Colorado's US 36

sensometrics[®] Enables Project Team
to Reliably Share Data and Cost Effectively
Enhance Asset Management

RESTORING ROAD SAFETY AFTER A THOUSAND-YEAR FLOOD

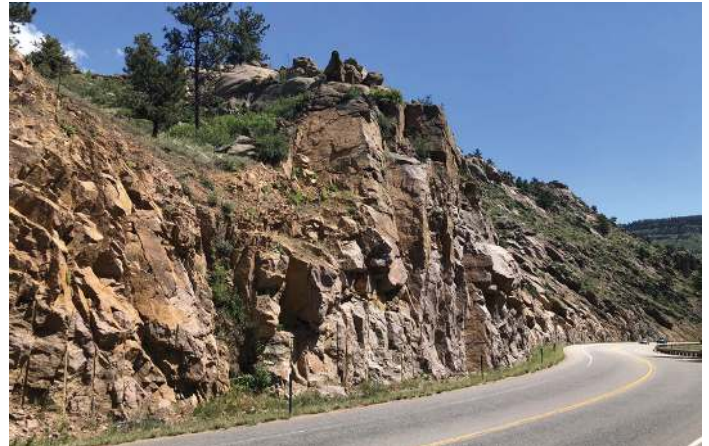
Data from the sensors provide a longer-term picture to understand ground and rock movements, helping prevent damage and ensure safety. Image courtesy of Shannon & Wilson.
